GORAN ZOVAK, M. Sc.
Fakultet prometnih znanosti
Vukelićeva 4, 10000 Zagreb, Republika Hrvatska
E-mail: zovakg@fpz.hr
GORAN BERAKOVIĆ, B. Criminalist
E-mail: goran-berakovic@net.hr
IVICA OSTRUN, B. Criminalist
PU brodsko-posavska
Mažuranićeva 9, 35000 Slavonski Brod, Republika Hrvatska
E-mail: ivica.ostrun@sb.htnet.hr

Traffic Safety
Review
U. D. C.: 656.087:614.88
Accepted: Aug. 30, 2004
Approved: Oct. 27, 2004

ANALYSIS OF RECONSTRUCTION OF A DANGEROUS SPOT AT 390 km OF A3 MOTORWAY ZAGREB – LIPOVAC

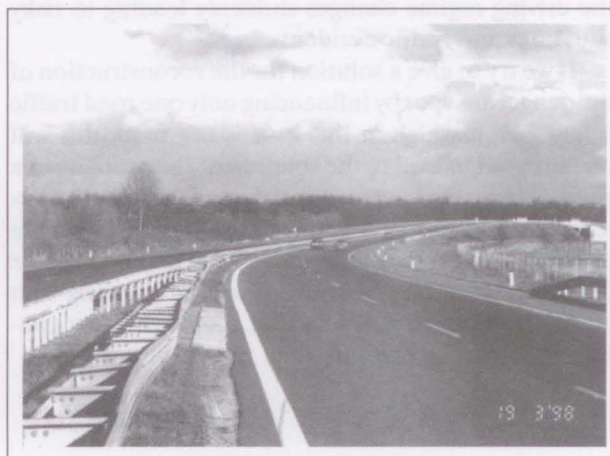
Following the described straight section there is sudden change in the driving conditions and there is a right curve, the radius of which does not meet the conditions of the calculated driving speed of the vehicle on the motorway, which is on a flyover passing over the railway line, which means ascending, and which is not well laid out. The additional aggravating circum-

The analysis of the causes of traffic accidents and the drivers' errors led to the conclusion that the drivers usually had not adapted the vehicle speed to the characteristics and the condition of the road as well as the visibility, and when they arrive to the beginning of the first radius of the mentioned curve they react by sudden change in direction and in vehicle speed resulting in the skidding of the vehicle on the road and running off the road.

Photo 1 - Condition of the considered curve before reconstruction

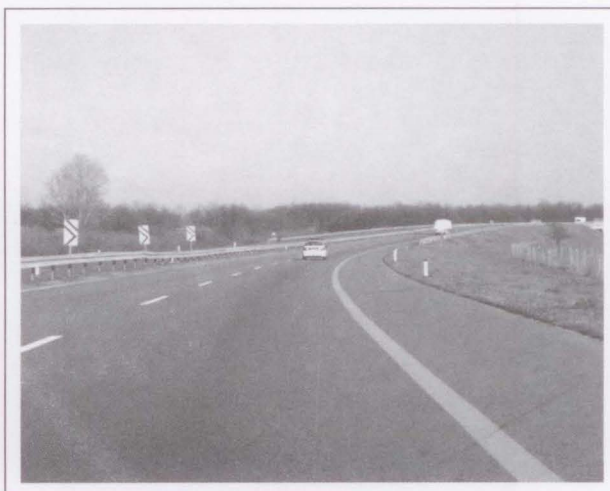
Photo 2 - Condition of the considered curve after reconstruction

- the physical curve layout should be visually marked,
- the curve should be marked by vertical traffic signalisation along the northern edge of the south road lane, above the central metal crash barrier, at the point of the break of the first and second radii of the curve longitudinally in the length of 300m, by setting the directional boards in a series. The first board from the west side would be set at 390+526 km, and from the east side at 391+800 km.

- the edge lines (yellow) should be painted in order to improve the proper guidance of the traffic flow,

The reconstruction activities at the mentioned dangerous spot were undertaken during the month of September 2002.
