Safety and Security in Traffic
Preliminary Communication
Submitted: Aug. 06, 2013
Approved: Nov. 11, 2014

EXPERIMENTAL STUDY OF NON-COMPATIBLE COLLISION OF RAIL AND ROAD VEHICLE

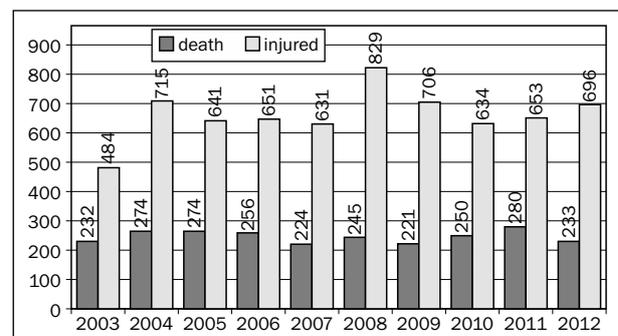
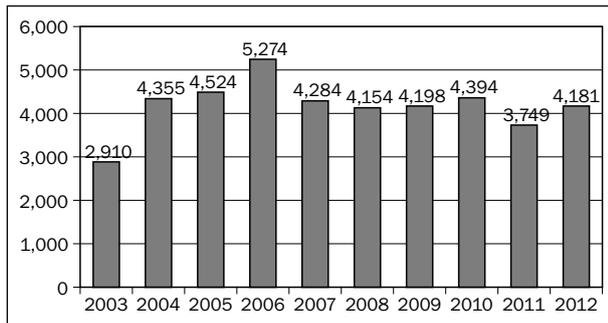
Figure 1a - Statistics of railroad accidents in the Czech Republic

Figure 1b - Development of the number of accidents

The survey of killed and injured people as a consequence of accidents and the development of the number of railroad accidents are presented in Figure 1a and 1b.

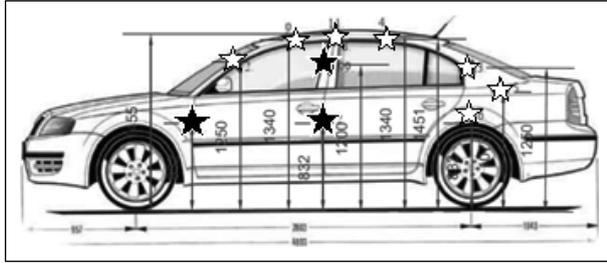
Figure 2a - Allocation of sensors on the left side of the car (white stars) and in the car (black stars)

Strain gauges Hottinger 1-LY11-10/350 were installed on chosen places of the car and seven accelerometers inside the car. The accelerometers were placed in the middle of the roof, on the floor tunnel and under the dashboard on the side of a front passenger. The crash test dummies (adapted Manikin) were placed on front seats and three-axis accelerometers were placed in their head and chest as well. The accelerometers were designed and produced in the Laboratory of Special Electronics of the Department of Security Technologies and Engineering at the Faculty of Transportation Sciences, the Czech Technical University in Prague. The allocation of the sensors is displayed in Figure 2 while the strain gauges placed outside the car body are marked as white stars and the accelerometers inside the car are marked as black stars. The allocation of strain gauges was almost identical in both tests.

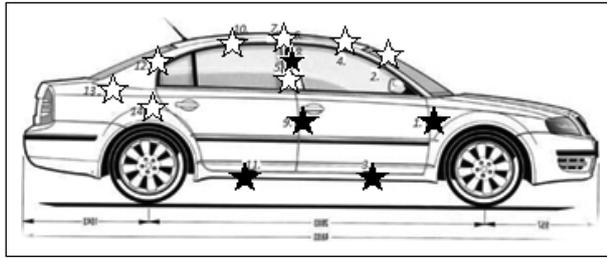
Figure 2b - Allocation of sensors on the right side of the car (white stars) and in the car (black stars)

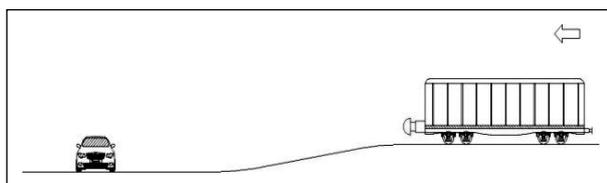
Figure 3 - The scheme of the experiment

The passenger car was placed on the rails perpendicularly to their axis and was centred (Figure 3). Two impacts were gradually led onto the vehicle from both sides. The first impact was made onto the left side of the vehicle by a standardized impactor used in railroad vehicle tests. The other impact was led up onto the right side of the vehicle by a tram headstock that is used when designing contemporary trams. Both the impactor and the headstock were fixed to a testing freight carriage, which was dropped from a hump in the gravity yard and which was immediately after the collision braked with wedges [4].

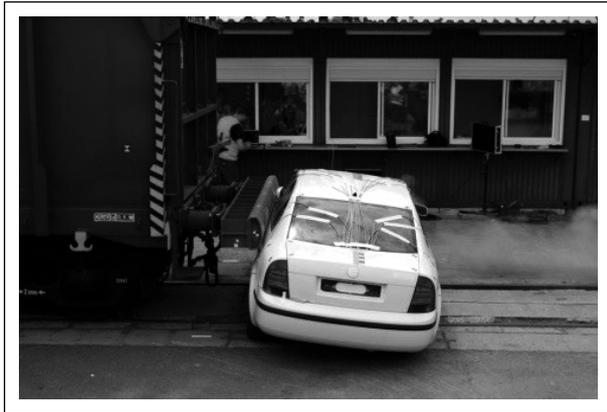
Figure 4 - Impact of a standardized impactor

The first impact test was carried out by a standardized impactor that is according to standards used in railroad vehicle tests. The impactor is made of a cylinder segment with an outer diameter of 250 mm fixed to a testing freight carriage of 80 tons weight. The impact speed was 4 kmph. The moment of impact is recorded in Figure 4.

Within the course of the collision only relatively small deformations of side structure of the vehicle appeared. The right side of the car was pressed towards the ground and the right front tyre was partly removed.

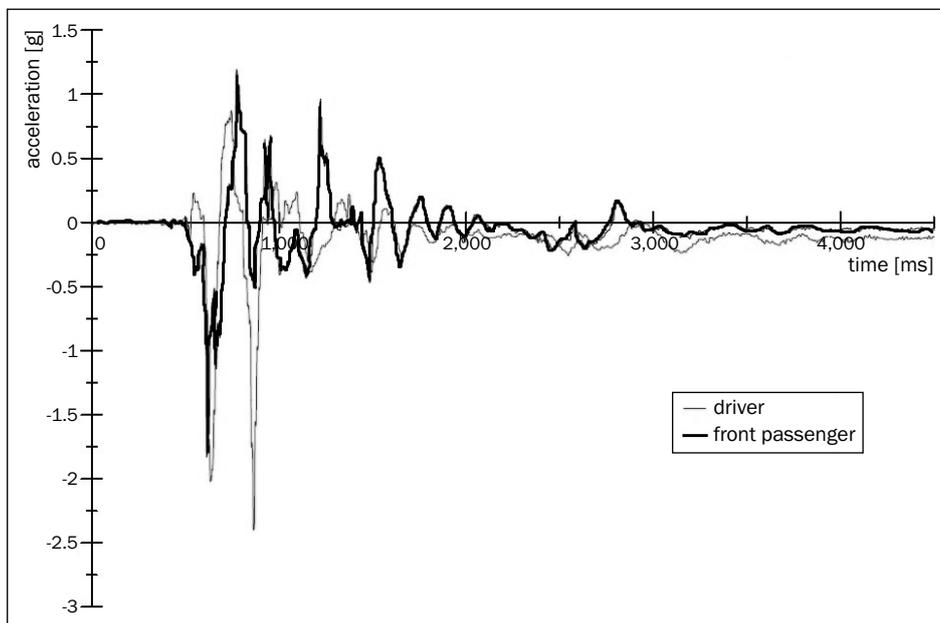
Figure 5 - The course of final acceleration in the heads of dummies during the impact

Figures 5 and 6 show the courses of acceleration measured by the accelerometers placed in the heads of the dummies and the courses of deformation of the car's structure calculated from the strain gauges data. As mentioned above the accelerometers recorded signal in three axes. The final course of acceleration, which was put together from particular components according to the formula is displayed in Figure 5:

my reached the value of about 2.5 g, in the case of the front passenger it was about 1.75 g. The value of HIC(d) criterion was in both cases comparable and it was calculated from the interval of 36 ms as 166, which is far below the limit of 1,000 [8].

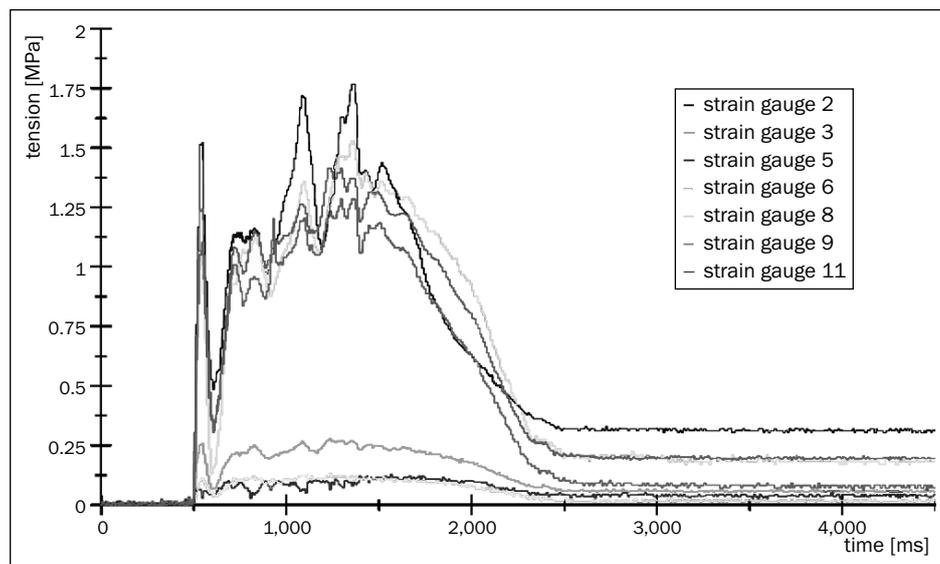
Figure 6 - The course of deformation of the selected parts of the vehicle

Figure 6 displays the course of deformation of the selected parts of the car body where the strain gauges were fixed. From the graph it is obvious that we can mostly observe elastic deformation of the side structure.

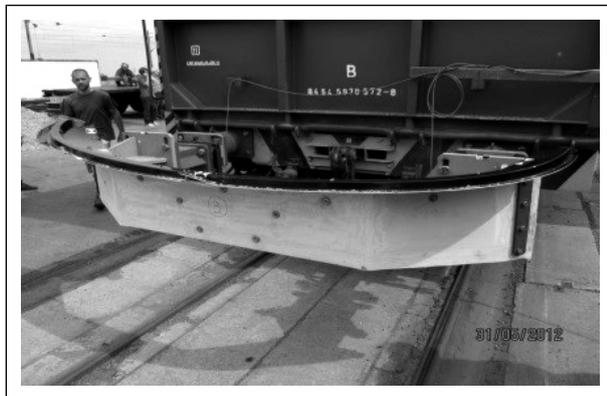
Figure 7 - Tram headstock

In the second test the same car, which was not damaged by the first test and its vital structures remained unharmed, was used. The collision was carried out by a tram headstock at a speed of 16 kmph (Figure 7).

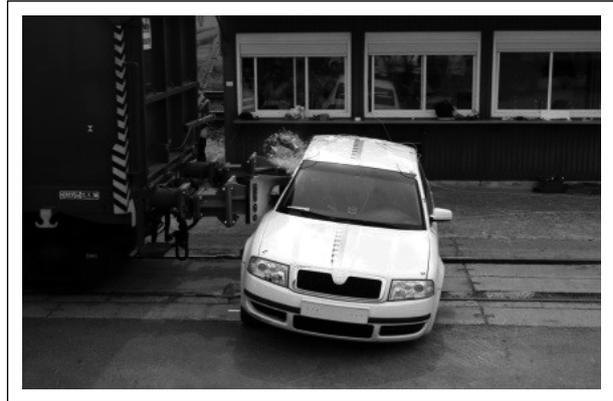
Figure 8 - The impact by a tram headstock

The moment of the impact is recorded in Figure 8.

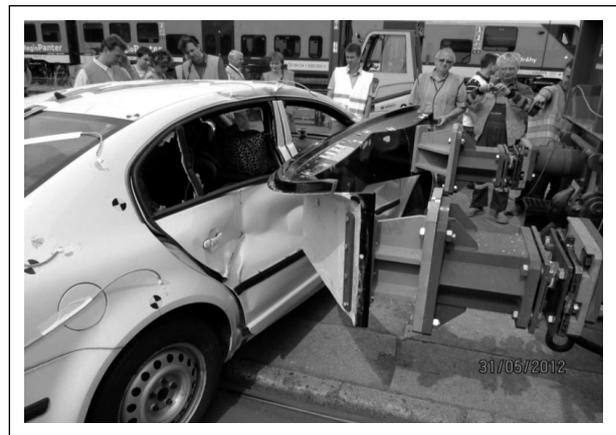
Figure 9 - The situation after the test

for about 10 metres, there was deformation of the right doors (front and back) and breaking of window panes on the right side. After visual inspection we could say that both the headstock and the car preserved their structure and mechanical features. The situation after the crash test is recorded in Figure 9.

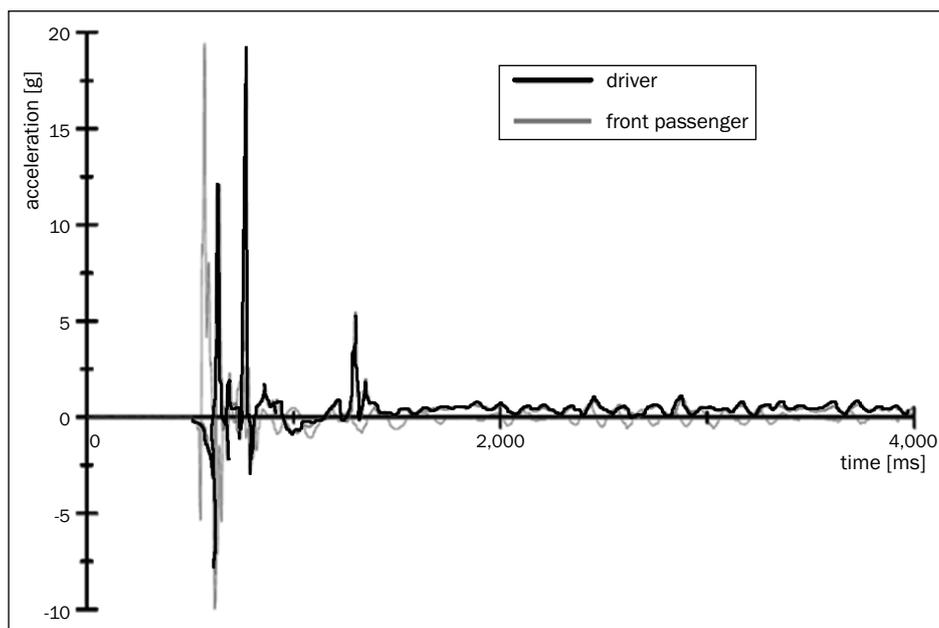
Figure 10 - The course of the resulting acceleration in the heads of dummies in the collision with headstock

The measured acceleration on dummies reached a comparable maximum value of almost 20 g. The course of acceleration in the head of the driver and the front passenger is displayed in Figure 10.

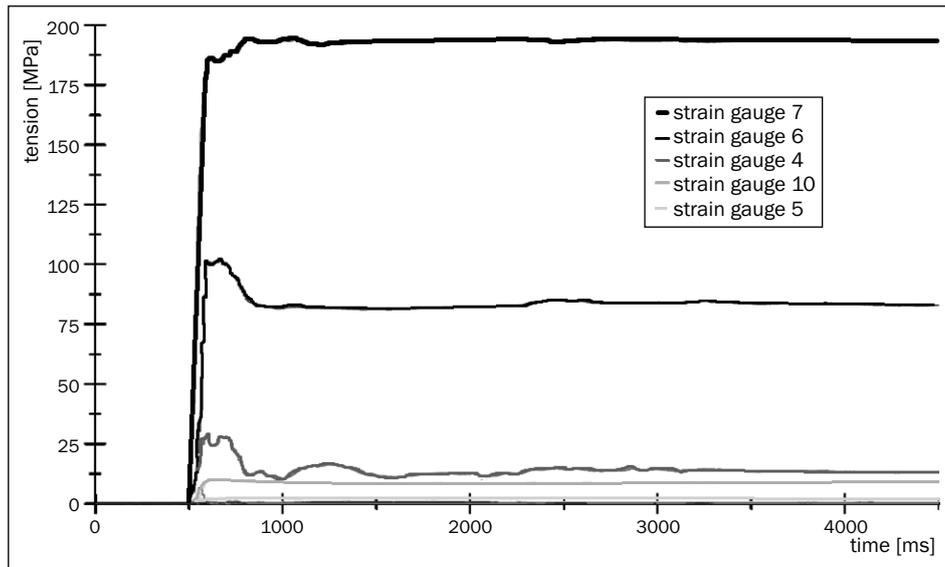
Figure 11 - The course of the strain in the car body in case of impact by a headstock

From Figure 11, which displays the courses of strain of selected car body parts, we can conclude that plastic deformation of the vehicle side structures and roof (strain gauge 4) prevails.

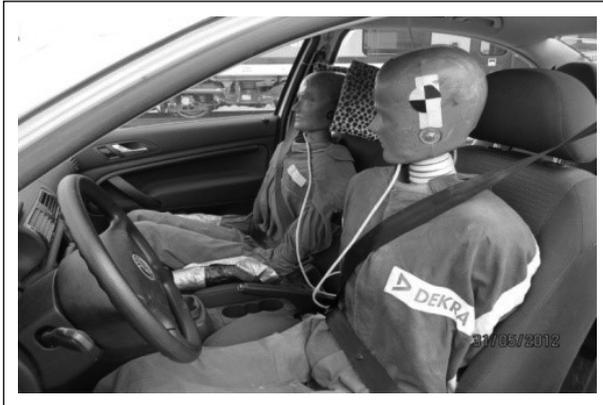
Figure 12 - View into the passenger car interior

The special headrest is made of an energy absorbing material and is fixed up with side guards for the head. The headrest is equipped with braces (a common design of conventional headrests) that can be placed into the existing holes of the headrests on the back seats of a vehicle.

The view into the passenger car interior is presented in Figure 12.
