Traffic in the Cities

Preliminary Communication

ANALYSIS OF VEHICLE VIBRATIONS – NEW APPROACH TO RATING PAVEMENT CONDITION OF URBAN ROADS

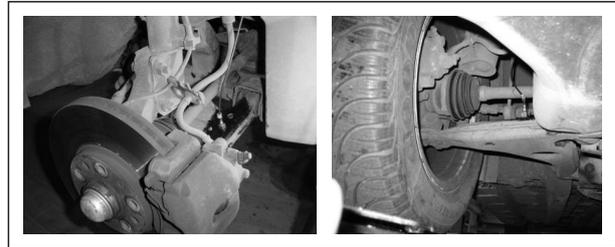
Figure 1 - Accelerometer A1 on the front wheel holder

The two accelerometers for vibration measurement were installed at an authorized dealer in Zagreb (Opel AutoWill). The first accelerometer (A1) was mounted on the front right wheel holder (Figure 1) and the second accelerometer (A2) was mounted to the chassis immediately next to the passenger seat (Figure 2). Vibrations in the vertical direction (perpendicular to the

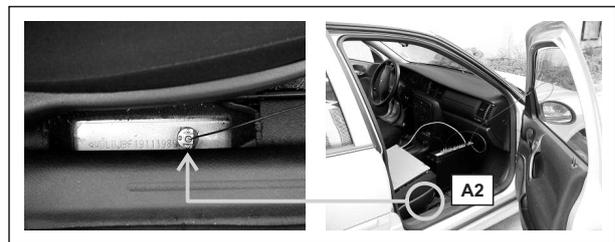
Figure 2 - Accelerometer A2 on the vehicle chassis

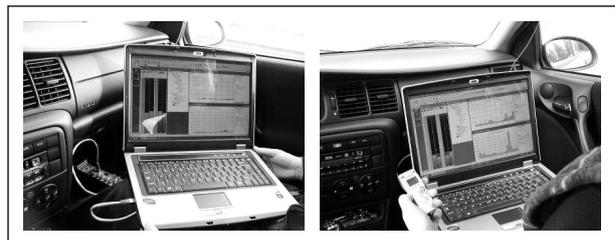
Figure 3 - Measuring equipment in the vehicle

road surface) were recorded using a battery-powered multi-channel Brüel & Kjær PULSE analyzer and the Time Data Recorder program (Figure 3). Information regarding some specific qualities during the measurement were recorded by means of a 'voice dictaphone' and a video camera.

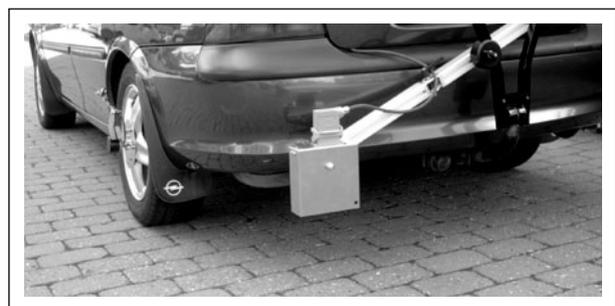
Figure 4 - Greenwood LaserProf device

terminated by technical regulations. In accordance with those regulations, measurement of the evenness of the driving surface was carried out on all road sections that are polygons for investigation. Since we wished to ascertain how much the riding comfort on the reconstructed road would improve, we measured the roughness before and after reconstruction. A Laser-Prof inertial profilograph manufactured by Greenwood Engineering was used for the measurement, Figure 4.

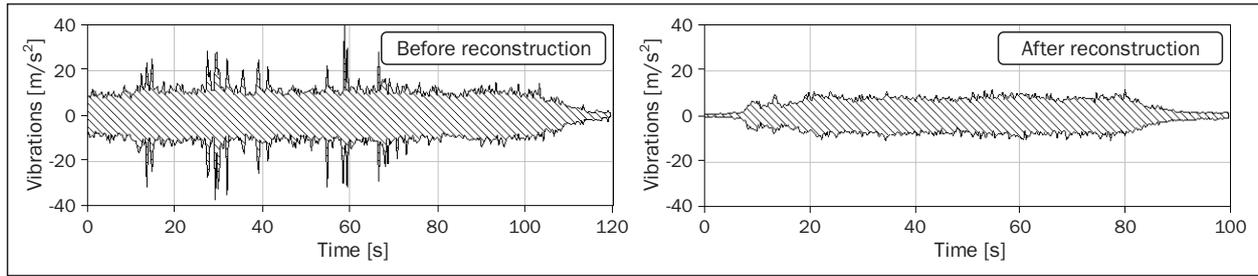
Graph 1 - Time profile of car wheel holder vibrations ($\pm 40 \text{ m/s}^2$)

As mentioned, the vehicle vibrations and road surface roughness were measured before and after the reconstruction of the Zagreb Avenue. The measurement of the vibrations of the car wheel holder (Graph 1) and the car chassis was carried out continuously at a constant speed of 80km/h. Graphs 2 and 3 present, in the same scale (0-100mm/s), the time profiles of the car wheel holder and the car frame (chassis) vibrations before and after reconstruction. The measured maximum values of wheel holder vibrations before reconstruction were 78mm/s on the 1st section (IRI: 3.28m/km) and 45mm/s on the 2nd section (IRI: 2.08m/km). After the reconstruction, wheel vibrations decreased to 21mm/s parameter (IRI: 1.28m/km). The maximum measured car frame vibrations before reconstruction were 15.3mm/s on the 1st section and 11.2mm/s on the 2nd section. After reconstruction, they decreased to 8.3mm/s. As can be seen in graph 3, the average value of wheel vibrations after reconstruction were not higher than 10mm/s, and the vibrations of the car frame were therefore not higher than 3mm/s.

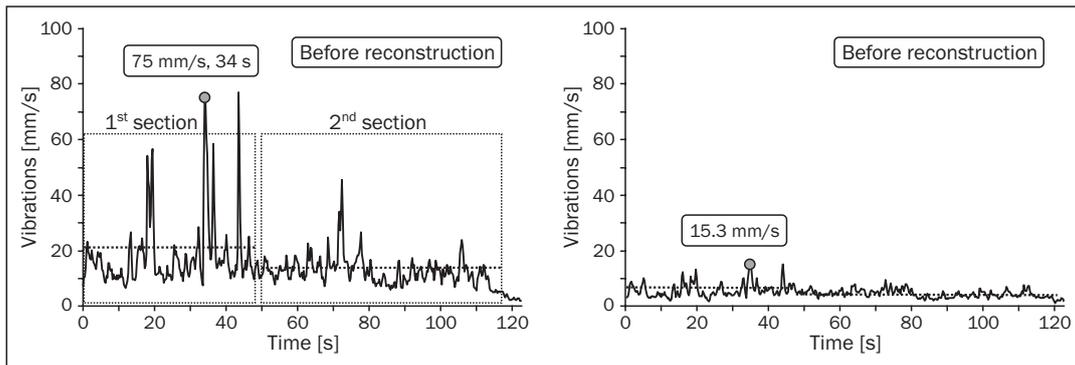
Graph 2 - Car wheel holder and car frame vibrations before reconstruction (Zagreb Avenue)

of the Zagreb Avenue have been taken into account before the reconstruction with respect to IRI. This fact is best illustrated in *Graph 2*, where the different values of measured vibrations can be observed. On the first section (from 0 to 48sec) where IRI parameter measures 3.28m/km, the average vibrations on the wheel holder measure 21.2mm/s while vibrations on the car chassis measure 6.1mm/s. On the second section (from 48 to 112sec) where IRI parameter measures 2.18m/km the average vibrations on the wheel holder measure 12.7mm/s while vibrations on

Graph 2 that the increase of wheel holder vibrations is 40 to 60mm/s and the vehicle chassis from 5 to 15mm/s in relation to the average vibrations appear on the pavement without potholes.

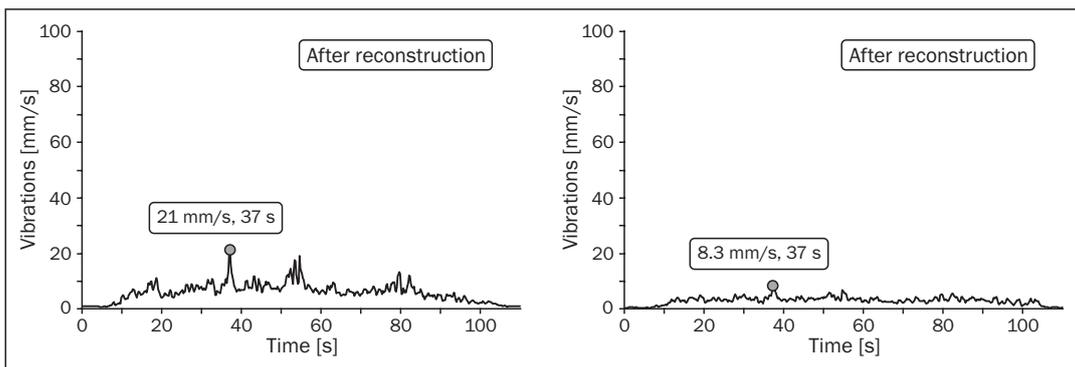
Graph 3 - Car wheel holder and car frame vibrations after reconstruction (Zagreb Avenue)

the car chassis measure 4.5mm/s. After complete reconstruction of the Zagreb Avenue, the IRI parameter (on both sections) measured 1.23m/km and the average of the wheel holder vibrations was 7.6mm/s, and of the car chassis 3.5mm/s. The results of these analyses are shown in *Table 3*. For the purpose of accurate definition of relations between the parameters of pavement evenness (IRI) and the vehicle vibrations, a correlation has been prepared on the basis of the stated quantities. The results of this analysis are shown in *Graph 12*.

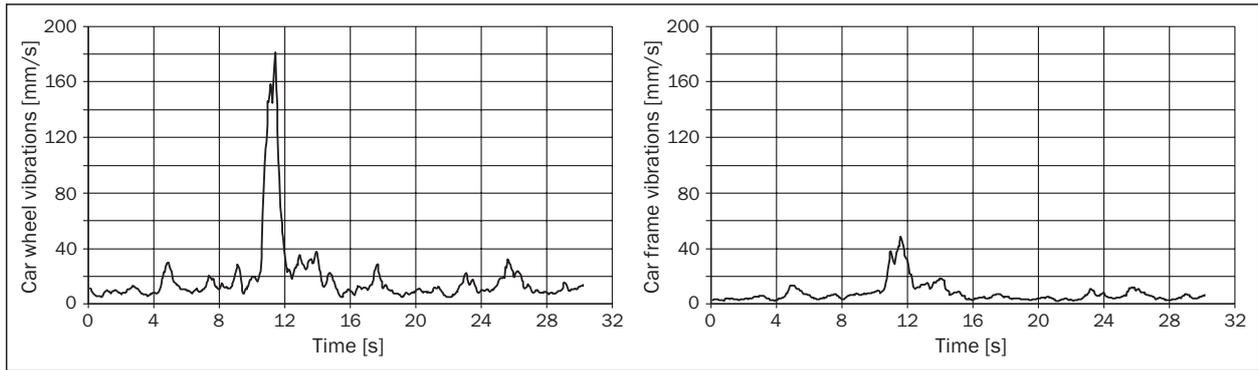
Graph 4 - Vehicle vibrations on Šubićeva-Zvonimirova intersection (before reconstruction)

The measured vehicle vibrations on Šubićeva-Zvonimirova intersection (before and after reconstruction) are presented in Graphs 4 and 5. The maximum

values of wheel holder vibrations were 180mm/s (before reconstruction) and 78mm/s (after reconstruction). Maximum car frame vibrations were up to

48mm/s (before reconstruction) and 30.5mm/s (after reconstruction).

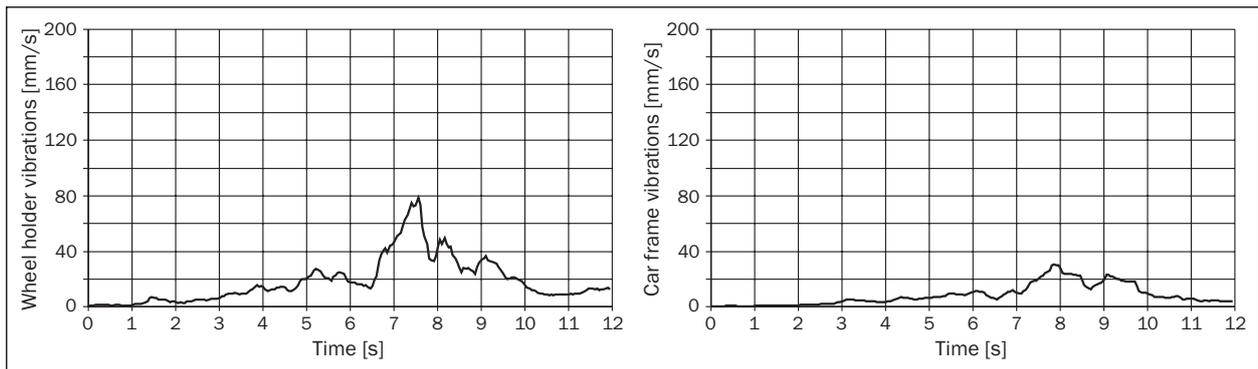
Graph 5 - Vehicle vibrations on Šubićeva-Zvonimirova intersection (after reconstruction)

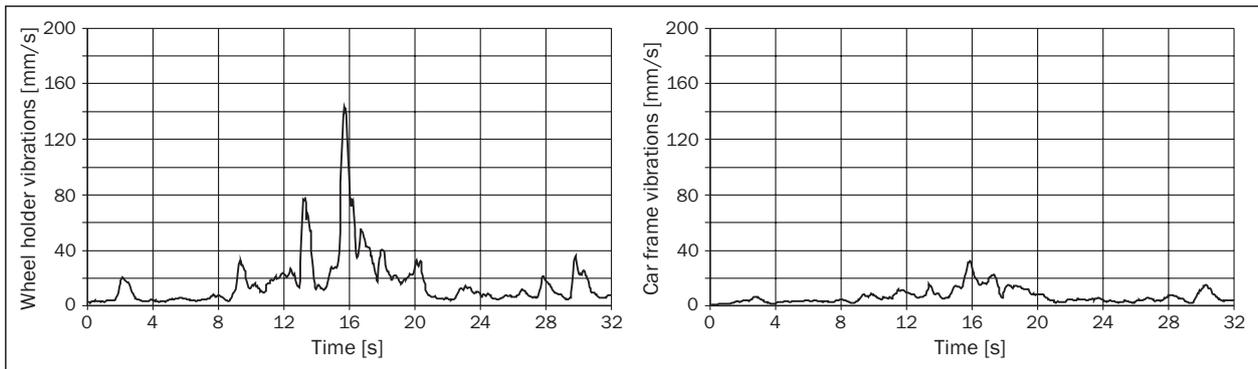
Graph 6 - Vehicle vibrations on Vukovarska-Držićeva intersection (before reconstruction)

The measured vehicle vibrations on Vukovarska-Držićeva intersection (before and after reconstruction) are presented in Graphs 6 and 7. The maximum values of wheel holder vibrations were 145mm/s (before reconstruction) and 35mm/s (after reconstruction). Maximum car frame vibrations were up to 32.5mm/s (before reconstruction) and 22mm/s (after reconstruction).

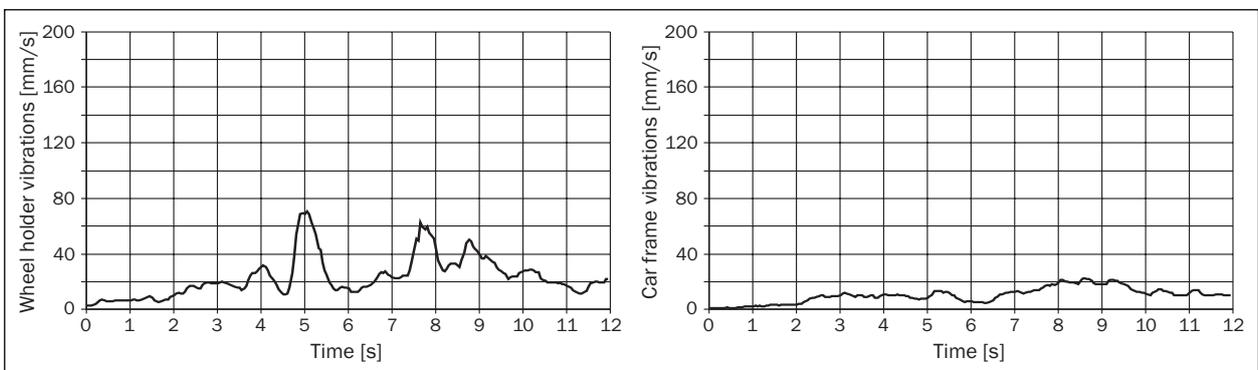
Graph 7 - Vehicle vibrations on Vukovarska-Držićeva intersection (after reconstruction)

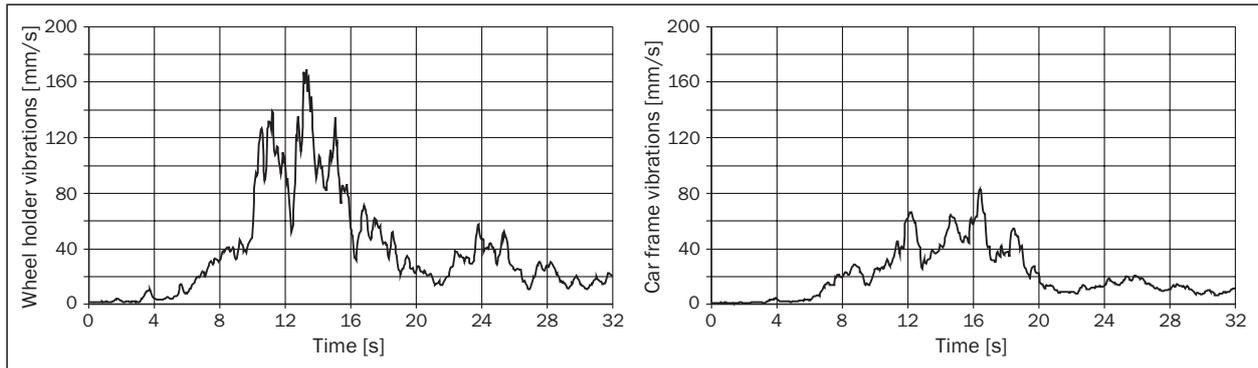
Graph 8 - Vehicle vibrations on Savska-Vukovarska intersection (before reconstruction)

The measured vehicle vibrations on Savska-Vukovarska intersection (before and after reconstruction) are presented in Graphs 8 and 9. The maximum values of wheel holder vibrations were 84.7mm/s (before reconstruction) and 35mm/s (after reconstruction). Maximum car frame vibrations were up to 41.2mm/s (before reconstruction) and 12.1mm/s (after reconstruction).

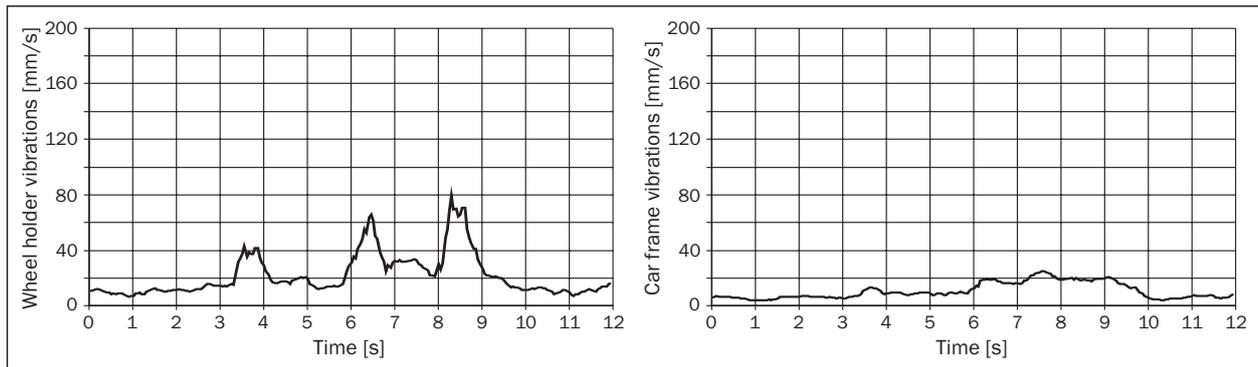
Graph 9 - Vehicle vibrations on Savska-Vukovarska intersection (after reconstruction)

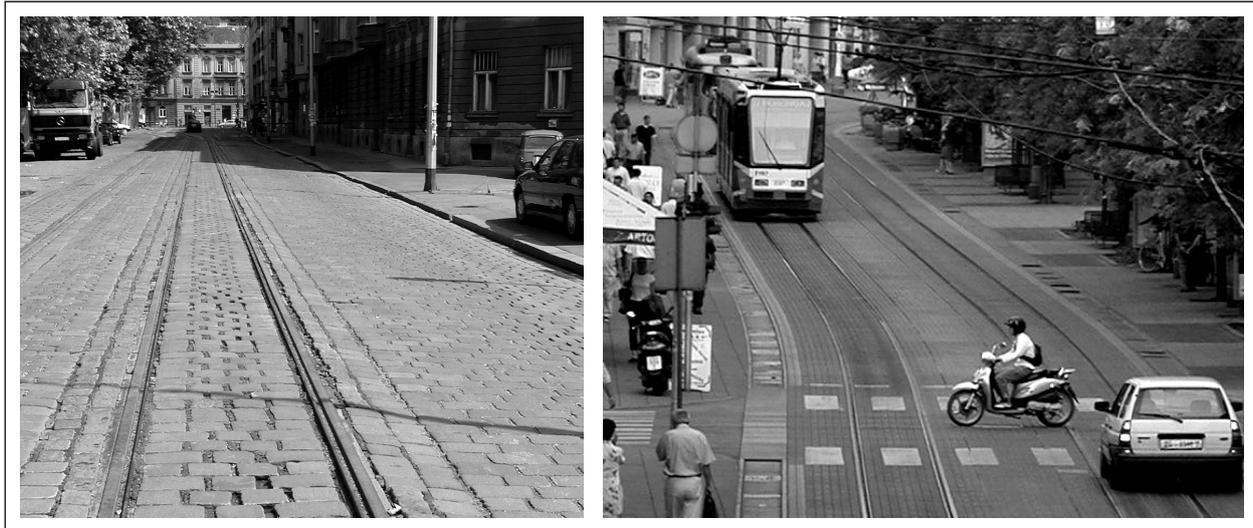
Figure 5 - Survey of tram track embedded in road surface

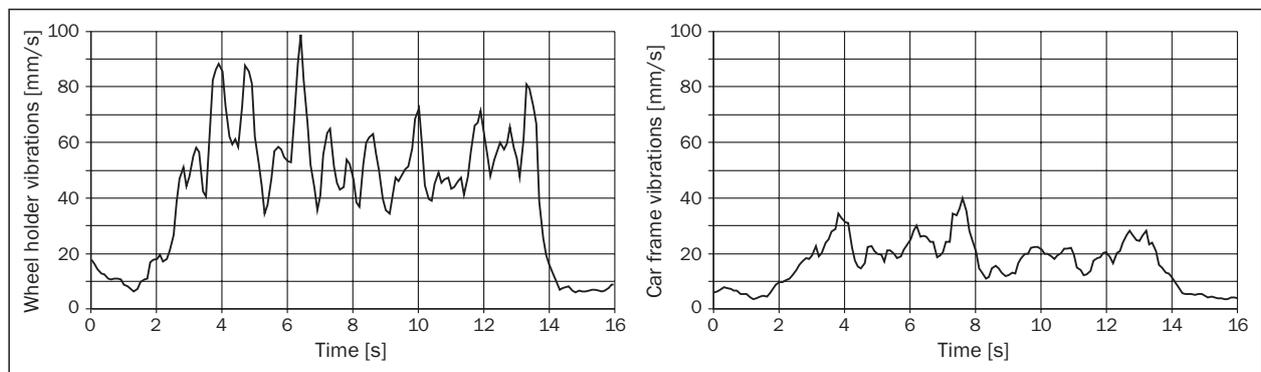
Graph 10 - Vehicle vibrations on tram track pavement with cobblestones

While driving over tram tracks, which are embedded in cobblestones, constantly increased vibrations were measured with a maximum of 98mm/s for wheel vibrations and 40mm/s for car frame vibrations, *Graph 10*. While driving over the tram track, which is embedded in concrete plates, considerably smaller wheel vibrations were measured (maximum 39mm/s), and the car frame vibrations were not higher than 10mm/s, *Graph 11*.

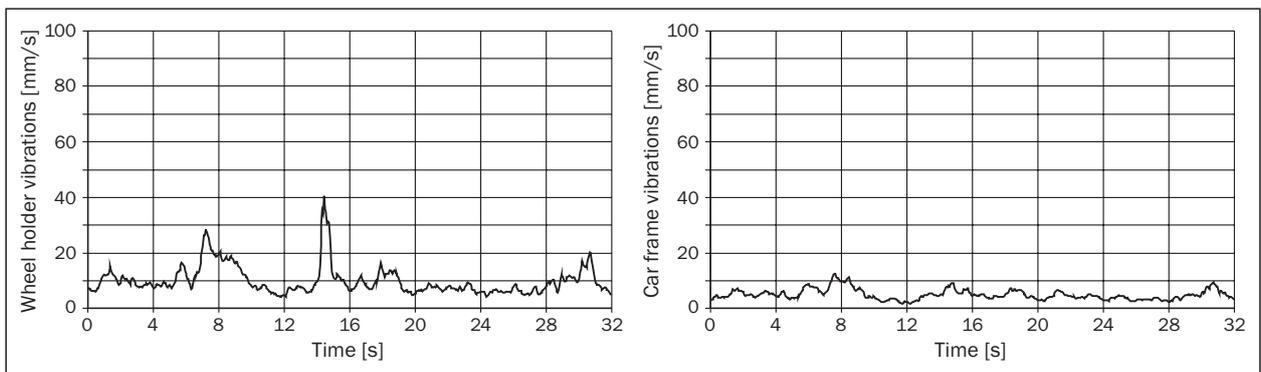
Graph 11 - Vehicle vibrations on tram track pavement with concrete plates

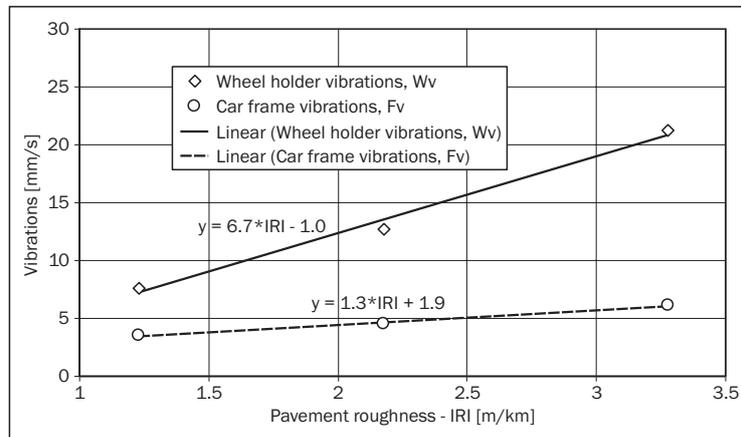
Graph 12 - Pavement roughness - vehicle vibration correlation (vehicle speed: 80 km/h)

Based on the previously measured evenness of the pavement driving surface, the graph estimates the vehicle vibrations quantity. As mentioned in the Introduction, vehicle vibrations are closely connected to the roughness of the road driving surface. If we consider the relative increase in vibrations at the moment of vehicle contact with the humps then it is obvious from

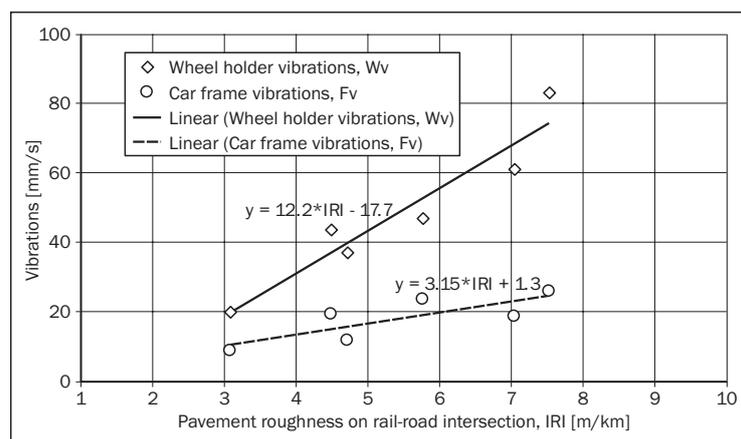
Graph 13 - Pavement roughness on rail-road intersection - vehicle vibration correlation (vehicle speed: 40km/h)

wheel holder vibrations can reach up to 180mm/s on a poorly maintained crossing. Correct and on-time maintenance of traffic infrastructure, especially of the crossings ensures less vehicle vibrations and consequently higher traffic safety, longer vehicle life span, less vehicle maintenance expenditure and more comfort for the users. The analysis of the average vehicle vibrations on the test polygon analyzed in the paper are shown in *Table 4*.

The average values are calculated only in the zone of crossings (from the moment of contact of the vehicle wheel with the first rail of the first railway track to the moment of crossing of the second rail of the second railway track in the crossing). The period for calculating the average vehicle vibrations in the zone of crossing is between 3 and 4 seconds. Due to the constant speed of 40km/h the period depends on the span between two railway tracks in the crossing.
