SILVESTAR PERŠE, D.Sc.  
DRAŽEN KOVAČEVIĆ, B.Eng.  
BRANKO MAKOVIĆ, B.Eng.  
Fakultet prometnih znanosti,  
Vukelićeva 4, Zagreb

Traffic Safety  
Review  
U.D.C. 656.08:614.86:616-001  
Accepted: Sep. 14, 1997  
Approved: Dec. 11, 1997

## ANALYSES OF FRACTURES THAT HAVE CAUSED TRAFFIC ACCIDENTS

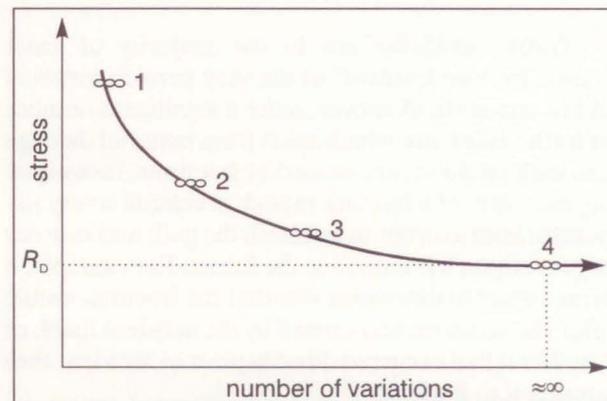
Figure 1 - Determining of dynamic endurance using Wöhler's curve

- 1 – fracture of the first three specimens
- 2 – fracture of the next three specimens
- 3 – fracture of the following three specimens
- 4 – no fracture occurred
- $R_D$  – dynamic endurance

Dynamic endurance is usually tested by pulsars and determined according to the Wöhler's curve. Such testing is valid only for the exact part (of certain dimensions, shape, machining condition, material, micro-structure condition, and type of dynamic load). The testing is carried out always on three specimens, such that the first testing begins by stress greater than the expected value for the dynamic endurance. After fracture of the first three specimens, the next three are tested at a lower load, thus increasing the number of variations. Testing is continued up to the stress at which the material can endure practically an infinite number of variations without failing (Figure 1).<sup>3</sup>
